# Manhole Inspection Summary

Manhole # S15KK1021MH

Insp Date: **6/19/07 9:01 AM**

**Location** Address: **2530 EDGECOMBE CIR N**

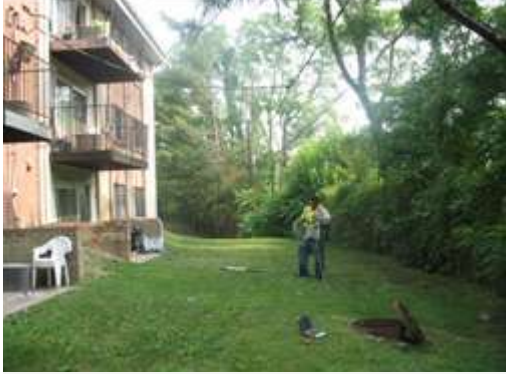
Location View

Comments **MH LOC. BEHIND APT. BUILDINGS..**

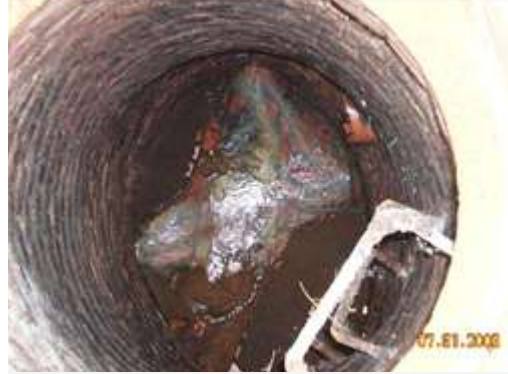
Top View

Corroded steps. Bench and Channel debris.

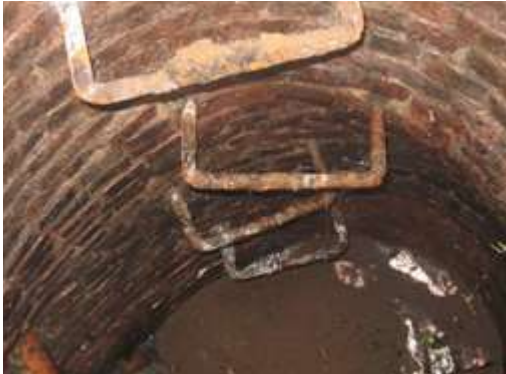
Defect

Barrel infiltration.

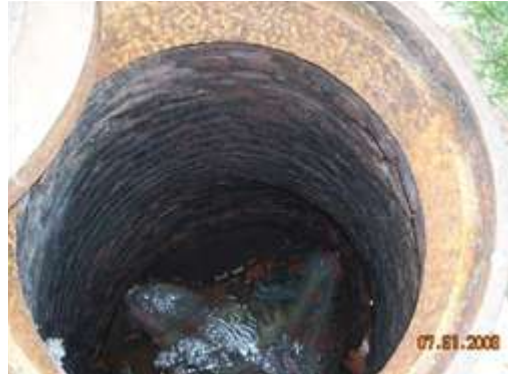
Defect

Adjustment deterioration and infiltration. Corbel and Barrel infiltration.

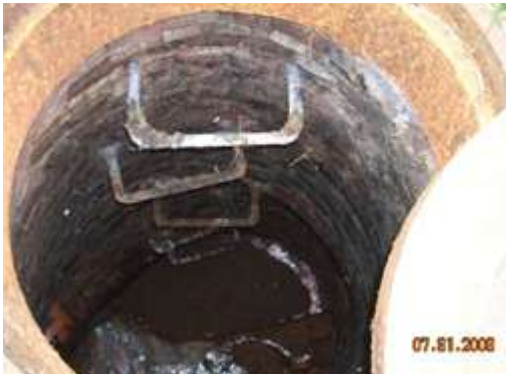
Defect

Adjustment deterioration and infiltration. Corbel and Barrel infiltration - other side.

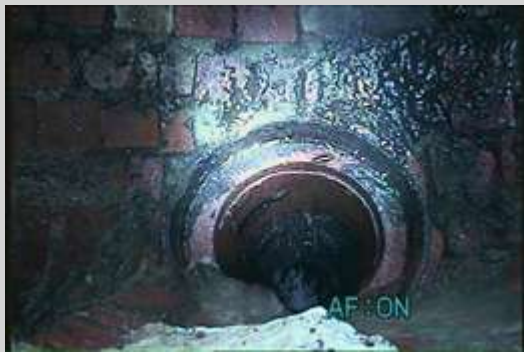
### 8 in. Circular Gravity Sewer Pipe Out @ 12 O'Clock

Infiltration: **Evidence** Pipe Seal Cond: **Unknown**

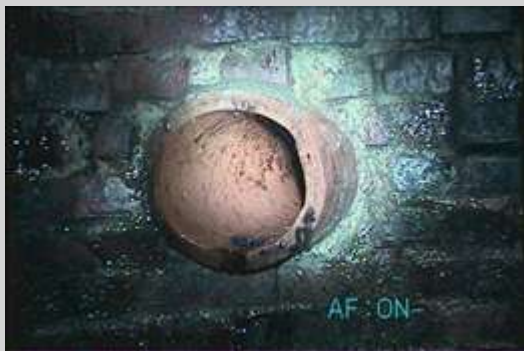
### 8 in. Circular Gravity Sewer Pipe In @ 3 O'Clock

Infiltration: **Evidence** Pipe Seal Cond: **Unknown**

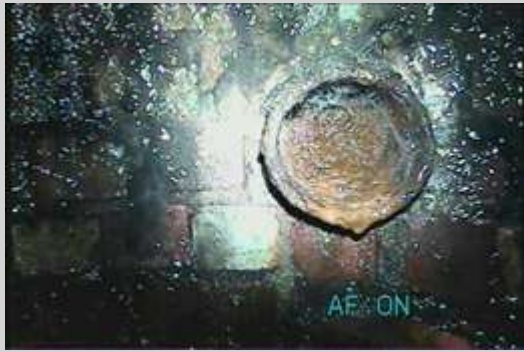
Pipe In @ 6 O'Clock

Deposits: ☐ None ☒ Mud ☐ Sludge ☒ Debris ☒ Grease

Silt Depth: **1.5** (in.) Deposits Extent: **Light**

Infiltration: **Evidence**

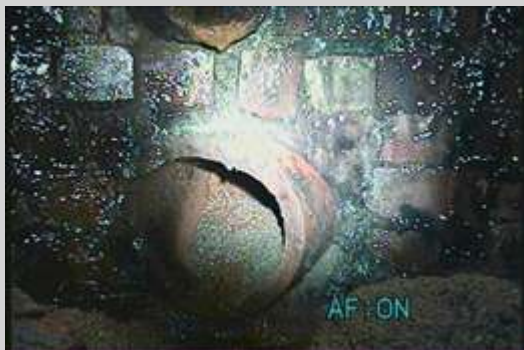
Pipe In @ 7 O'Clock

Infiltration: **Evidence**

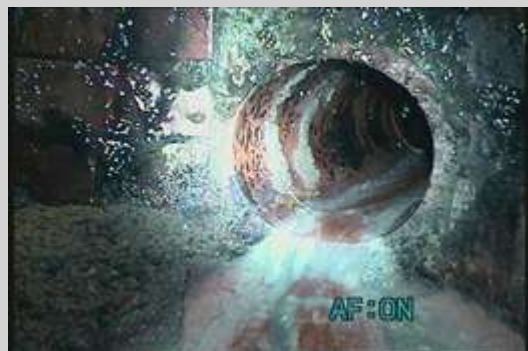
Pipe In @ 8 O'Clock

Infiltration: **Evidence**
